ROVVER 400 Video Inspection Robot

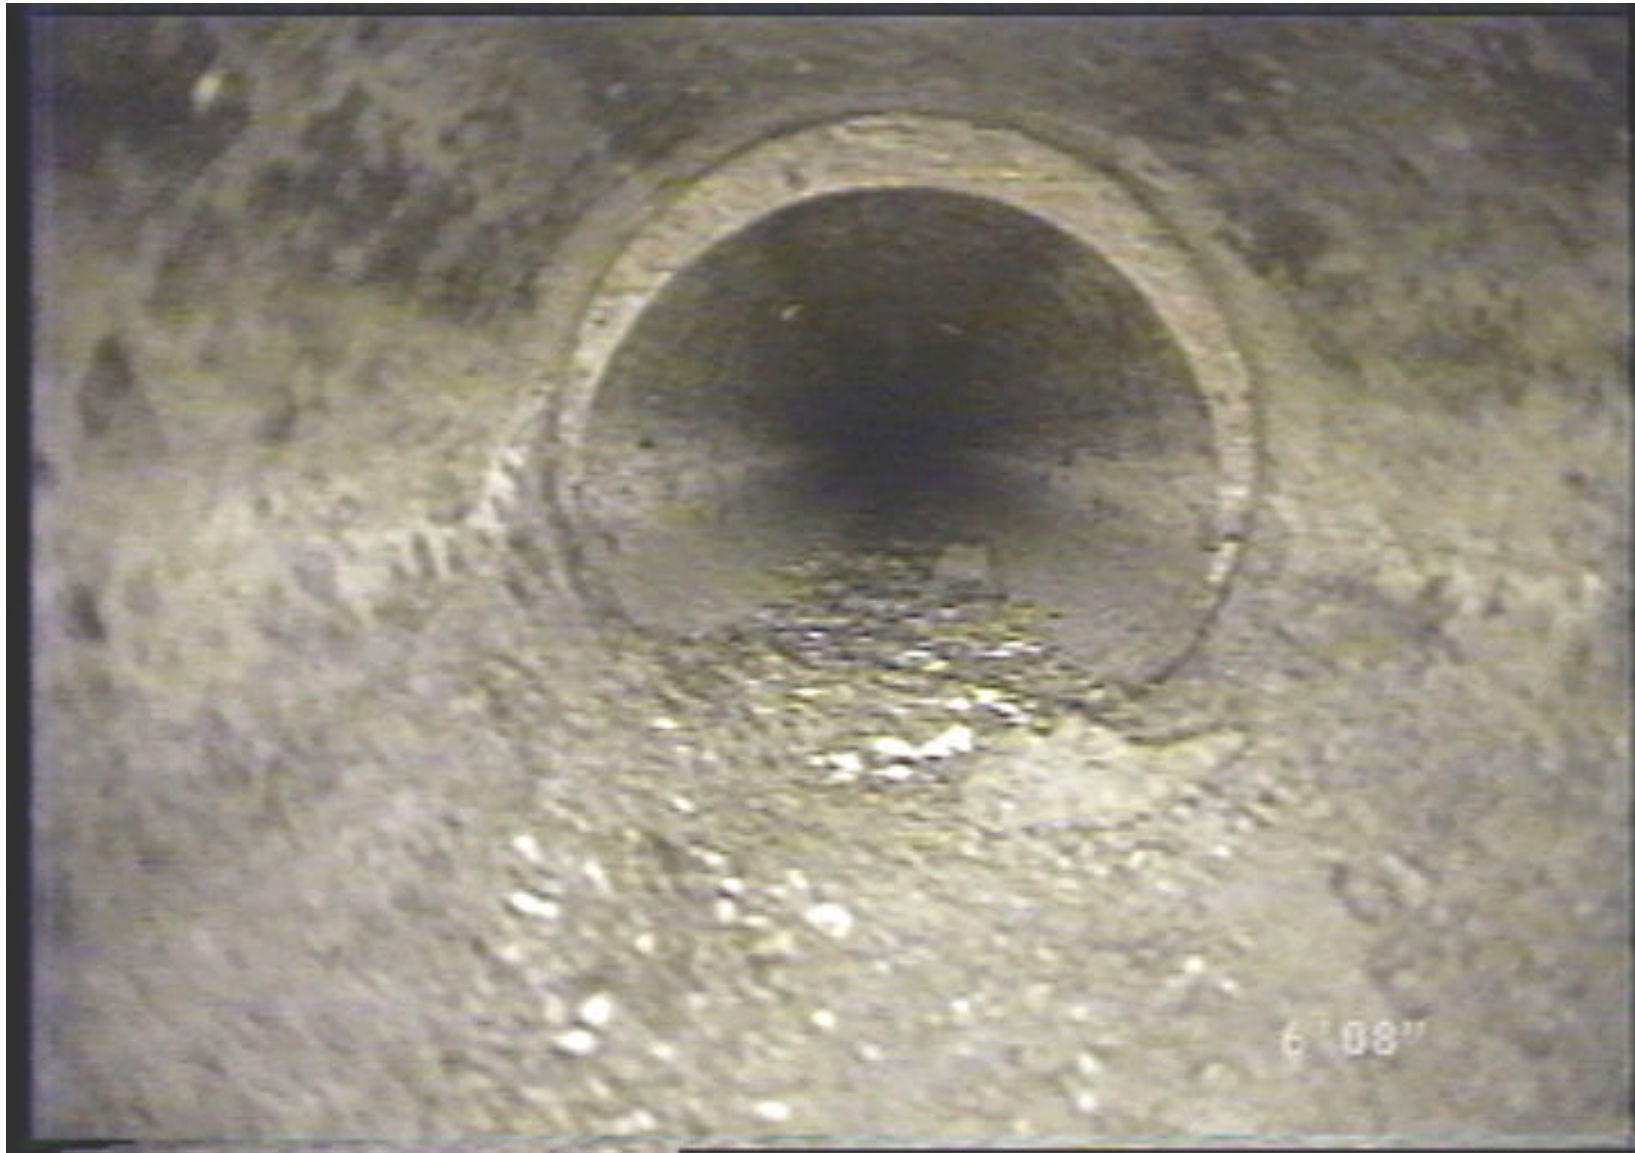
Failed joint in drain line running from WEDF to PBF-16 leach pond.

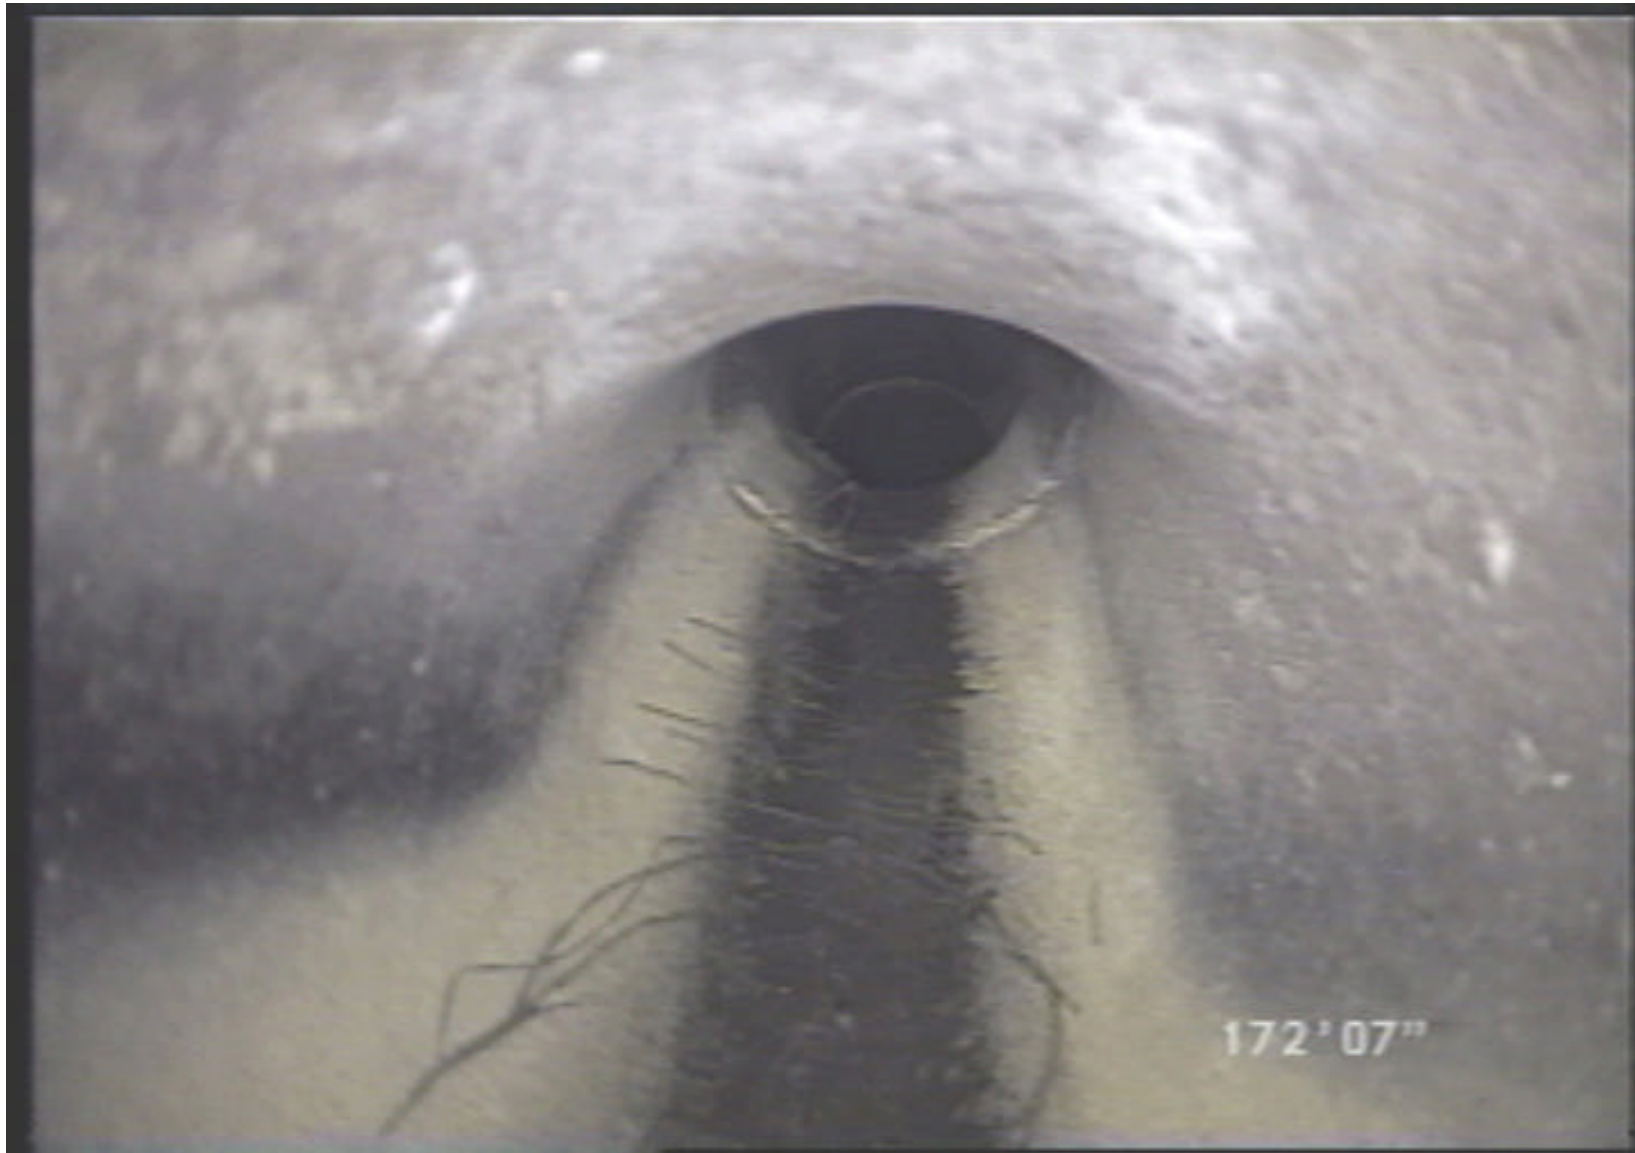
Elbow leading to out-of-service drain in WEDF.
